PRELIMINARY PATHWAY ANALYSIS REPORT

RAHKONEN DRUMS
CERCLIS ID# UTD981545981

U.S. ENVIRONMENTAL PROTECTION AGENCY
REGION VIII

September 29, 1993

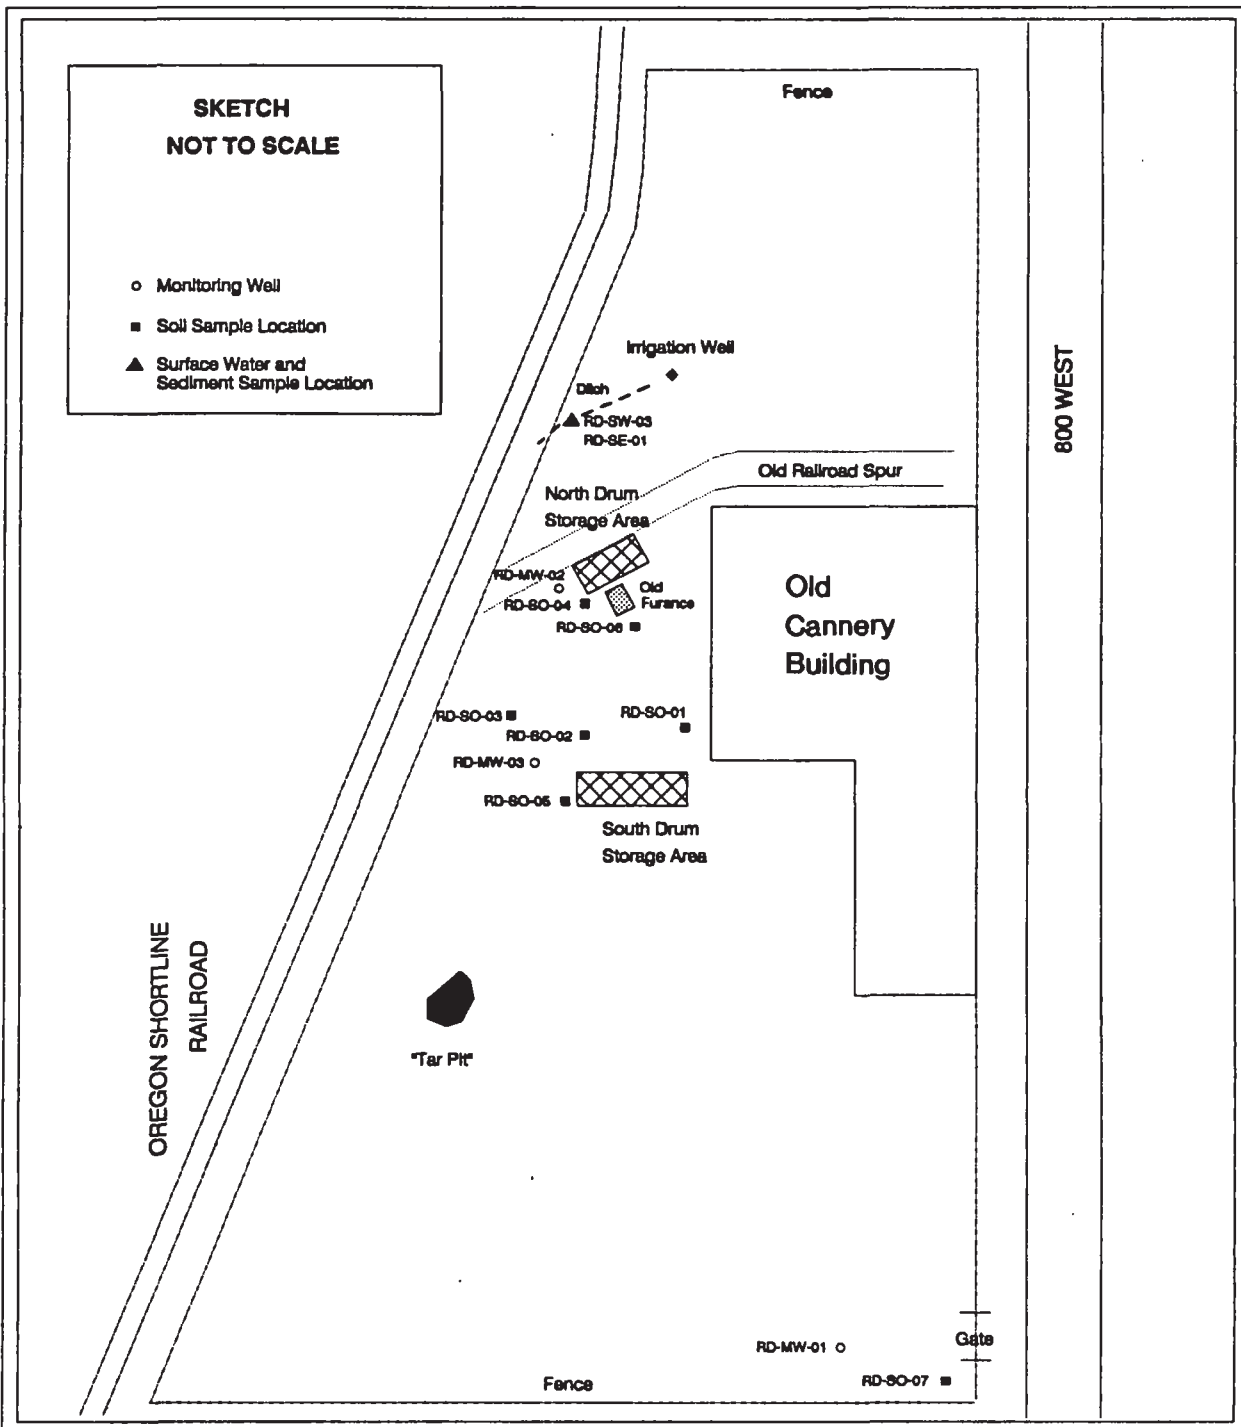
Figure 2

The property covers approximately 8 acres, most of which are open fields and old buildings (Figure 2). The old buildings were once used in a cannery business (thought to be in operation in 1946) (Ref. 2). Concept Industries and Associated Manufacturing, a cabinet producer, has also used buildings onsite (time frame unknown) (Ref. 3). The U.S. Geological Survey 7½ minute topographic maps of the site (Ref. 7) show that the number, shapes and sizes of the buildings have increased and decreased through the years. The area on Figure 2, referred to as the Old Cannery Building is the area where the changes to the structures have occurred.

During a site visit by the BSHW on January 5, 1990 two separate areas containing drums were observed. The drum areas are referred to as the north and south drum storage areas. These drum areas are located in an open field west of the old cannery buildings (Figure 2). Mr. Rahkonen began storing drums at the site in 1983 (Ref. 1).

The leaking drums onsite are the principal hazardous waste found. The on-site drums are clustered in two locations (Figure 2). During an October 27, 1986 site inspection by Ms. Laurie Goldner of the BSHW, contents from drums in the drum storage area were seen covering a portion of the concrete slab. The thickness of the spill was approximately 1 inch. Berms or other impounding structures were not present (Ref. 1). The location of this drum storage area was not mentioned in this report. However, several statements from other inspections lead to the conclusion that the drums are located at the northern drum storage area. During a site visit on July 1, 1987 materials leaking from the drums were observed to be flowing onto the ground (Ref. 1).

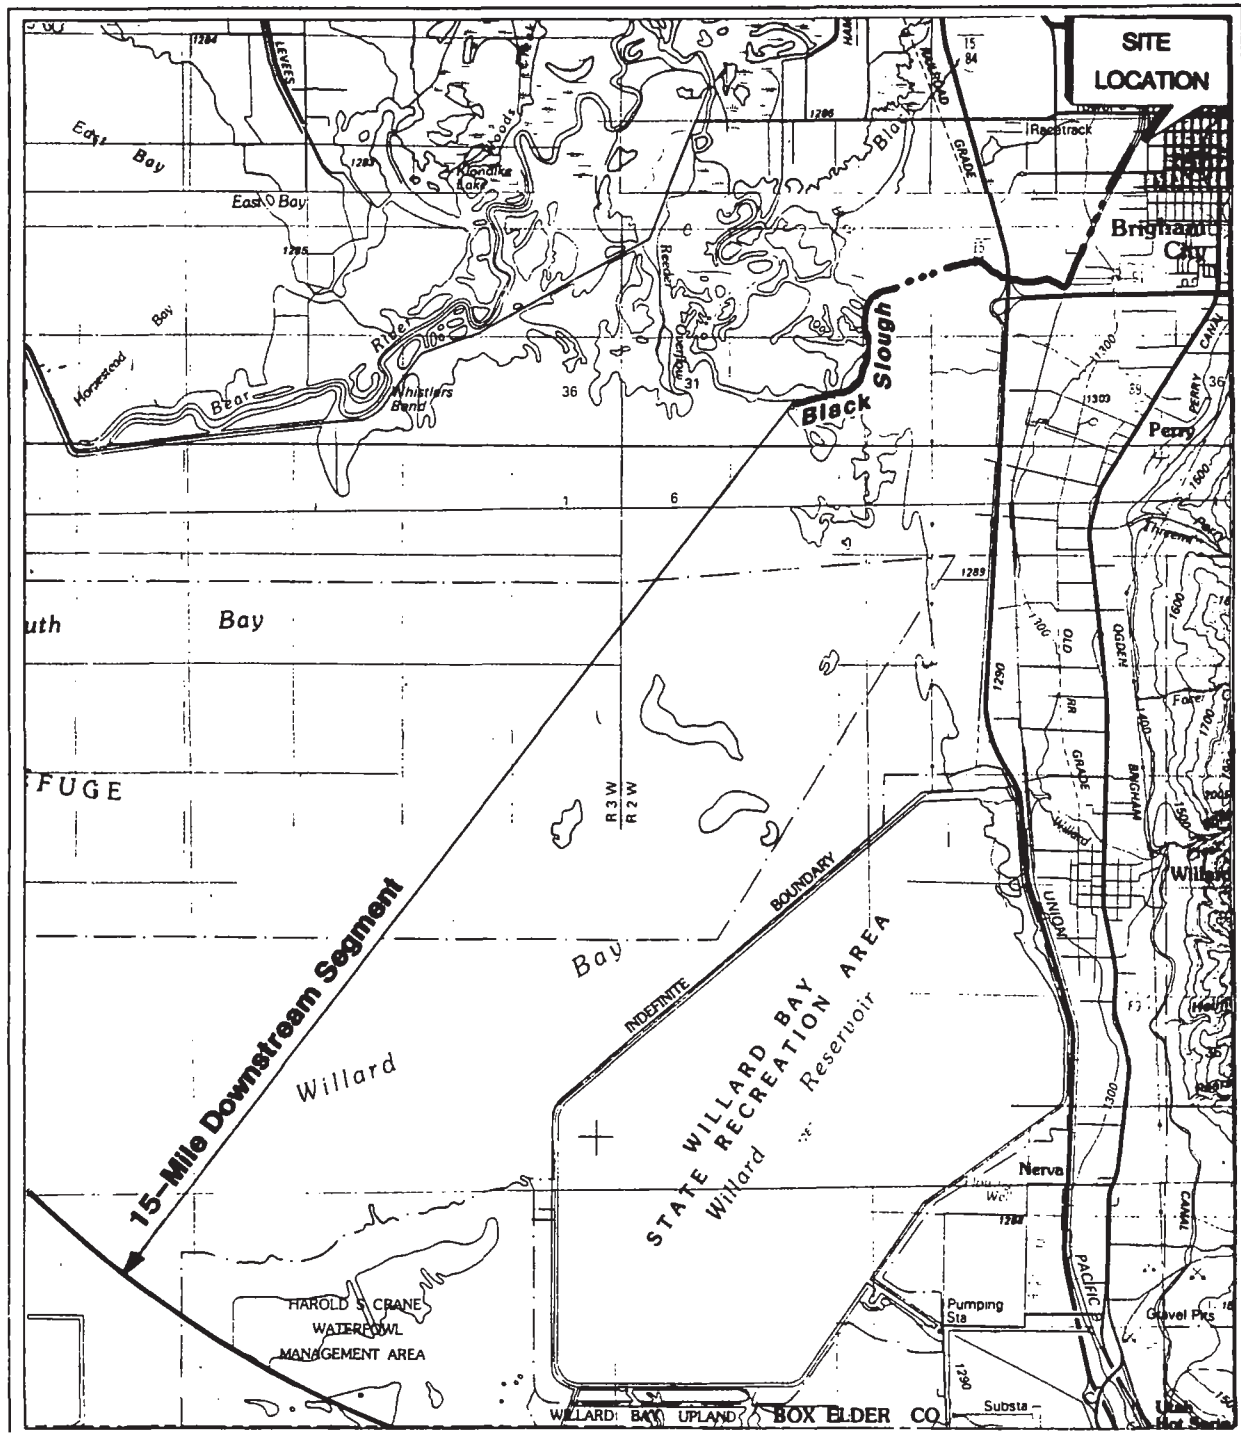
Numerous wetlands are located west of the site. The nearest wetland is located approximately 1 mile downgradient of the site. The Bear River Migratory Bird Refuge wetlands are about 4 miles west-southwest and downstream of the site (Ref. 3). The Harold S. Crane Waterfowl Management Area is located approximately 12 miles southwest and downstream of the site. Both the Bird Refuge and the waterfowl area are located in Willard Bay of the Great Salt Lake. These features are illustrated in Figure 3 (Ref. 5).

runoff) leaving the site (Ref. 2). Run-off from the site could eventually reach Willard Bay approximately 4 to 6 miles downstream of the site (Figure 3) (Ref. 5).
